Manhole Inspection Summary

Manhole # S33M__012MH

Insp Date: **3/7/08 2:00 PM**

Location Address: **611 hanover**

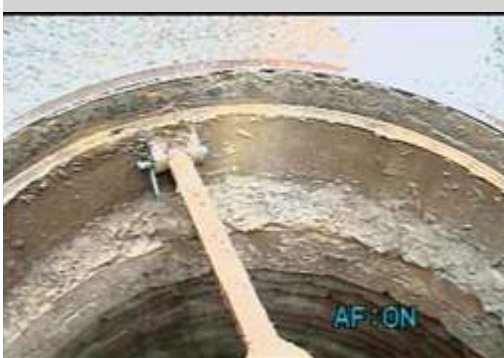
Defect 1

Offset: **4** (in.)

offset

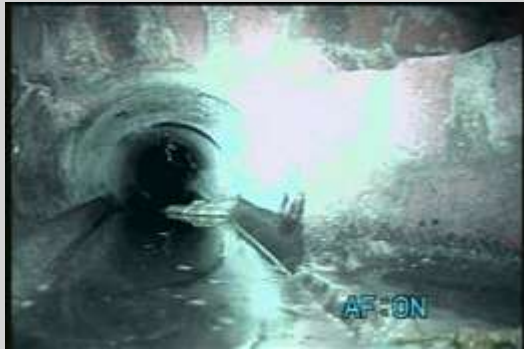
12 O'Clock Outflow

8 in. Circular Gravity Sewer
Pipe Out @ 12 O'Clock

Pipe Material: **Clay** ☐ Pipe Lined

Invert Depth: **12.60** (ft.) Flow Characteristics: **Fast**

Infiltration: **None** Pipe Seal Cond: **Unknown**

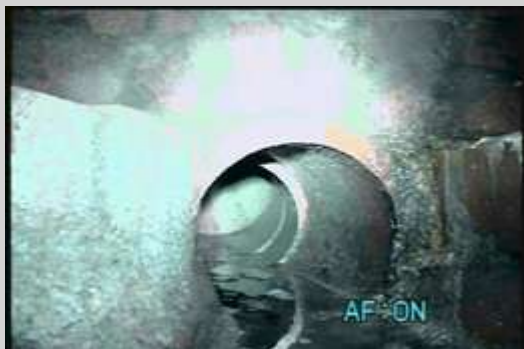
3 O'Clock Inflow

8 in. Circular Gravity Sewer
Pipe In @ 3 O'Clock

Pipe Material: **Clay** ☐ Pipe Lined

Invert Depth: **10.00** (ft.) Flow Characteristics: **Fast**

Drop: **Inside** **Direct**

Inv Depth: **12.30** (ft.)

Drop Condition: **Open**

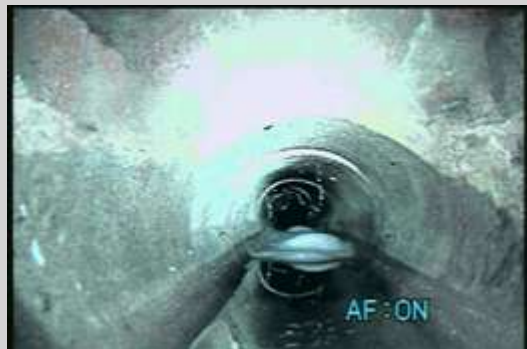
6 O'Clock Inflow

8 in. Circular Gravity Sewer
Pipe In @ 6 O'Clock

Pipe Material: **Clay** ☐ Pipe Lined

Invert Depth: **12.40** (ft.) Flow Characteristics: **Slow**
